75 AND ZT CLUB TECHNICAL INFORMATION DOCUMENT

Model: Rover 75 / MG ZT and Tourer models

Ref: TID-002

Title: LOWER PLENUM WATER DRAIN UNBLOCKING AND MODIFICATION

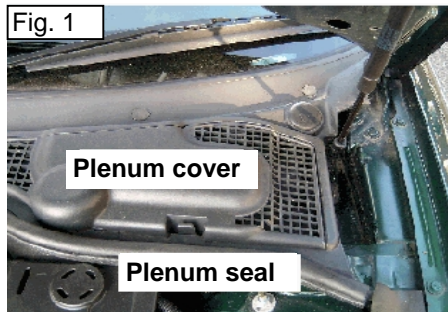
Fig. 1

Description: This document is intended as a guide to unblocking the lower plenum drainage system. In some instances the lower bonnet plenum area retains water and will not drain away of its own accord. In some instances blockage of the drainage system can cause the plenum area in which the ECU sits to flood and affect ECU performance.

1. Open bonnet
2. Remove LH plenum access cover (fig.1)
3. Pull back plenum seal (fig.1) to centre of vehicle
4. Remove 2 plenum clips using a small flat screwdriver and 1 plenum scrivet fixing with philips screwdriver(fig.2)
