Bonnet Lock Mechanism All Models

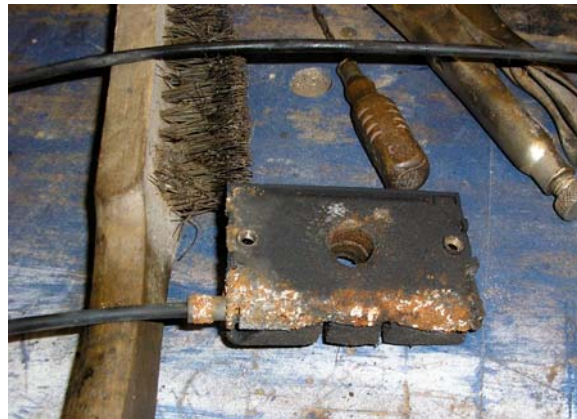
The picture on the right shows a unit which has been removed. The housing is in two sections and is aluminium and plastic. The metal section is the bottom half of the unit. You will see the extent of what appears to be corrosion on the metal section.

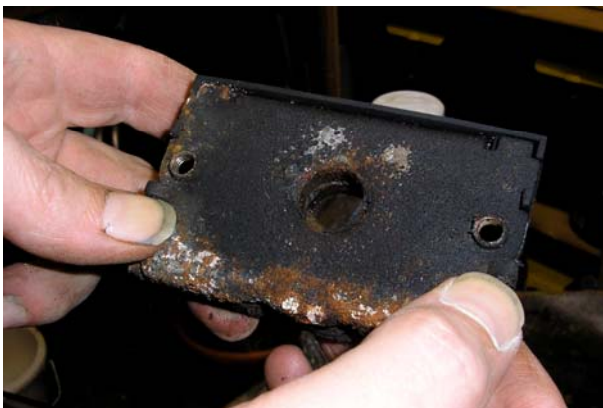
Here is a unit ready to be split. You can just see that the lever is not even visible in the pin locator hole, meaning that it is stuck open and will not clamp the pin when it descends. The two halves are held together by the plastic section clipping to the metal part, shown here next to the thumbs in the picture. These prise away slightly and the two halves will split.....

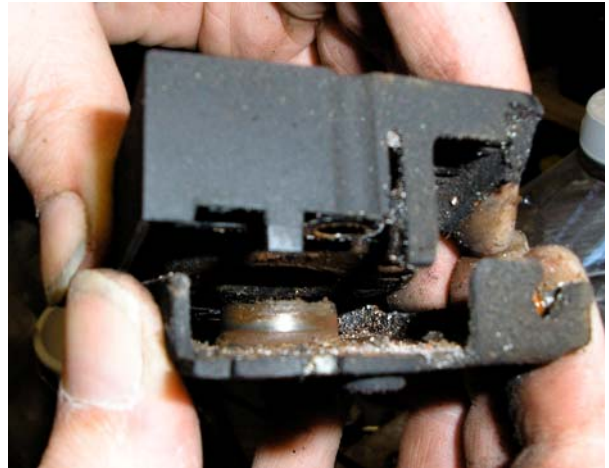
As shown in this picture the sections are being gently broken apart. The internal components are not fixed in place and so care should be taken to open whilst holding the unit level. You can also begin to see the amount of dirt inside.....

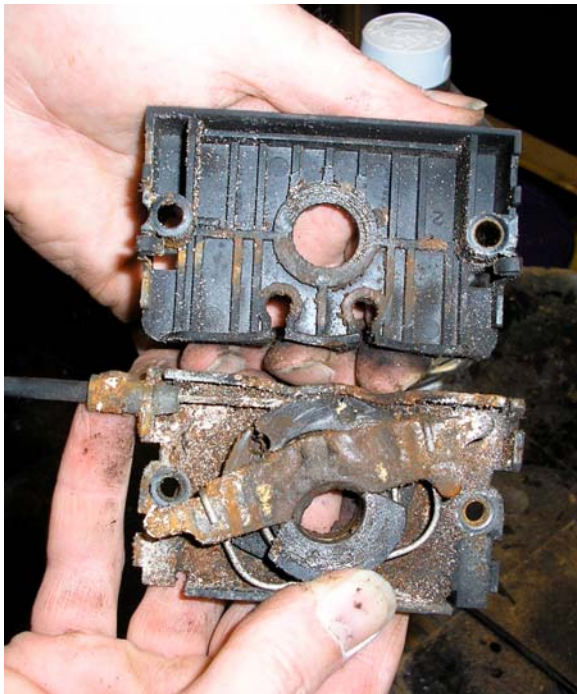
The unit now split. You can see the assembly of the parts despite the accumulation and their construction. Note the lever; the part must be assembled the correct way up with the chamfer edge on the striker area facing toward the plastic section.

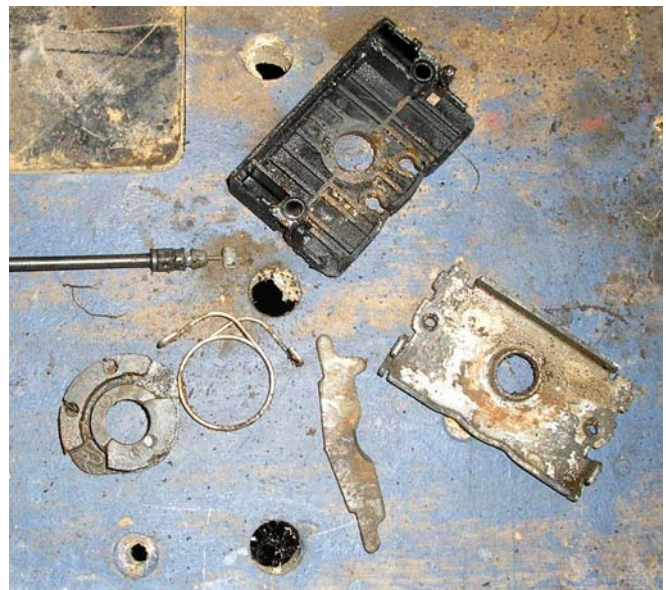
The components shown after disassembly. Just five parts and they can all be easily removed and put together again without needing any tools. Note the circular pivot part towards the bottom left of the picture next to the spring. This is also plastic and so only requires cleaning in some white spirit along with agitation using a brush to remove the dirt – as the central hole locates it in the metal section it should not be scraped or attacked with abrasives. The metal components can be wire brushed back to remove the crud.

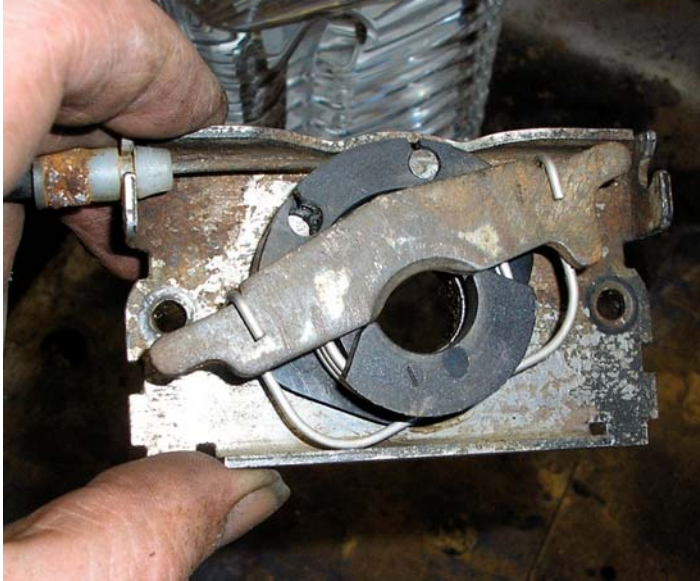
Now the same unit after cleaning, scrubbing and wipe dry followed by reassembly to check for operation. Again note the way in which the lever is mounted in the aluminum section with the chamfer on the striking edge facing out in the metal housing, and that it is now protruding nicely into the pin locator hole. The picture shows the lever at an upwards angle – it should be level to clear the two bolt holes for fixing back on the platform when pushing the housing together. The cable dowel should be pressed into the right-hand locator to allow for any slight stretching.
