Traffic Alert System

Rover 75 04 MY (UK market only)

MG ZT 04 MY (UK market only)

Sympton: Traffic Alert System Not Working

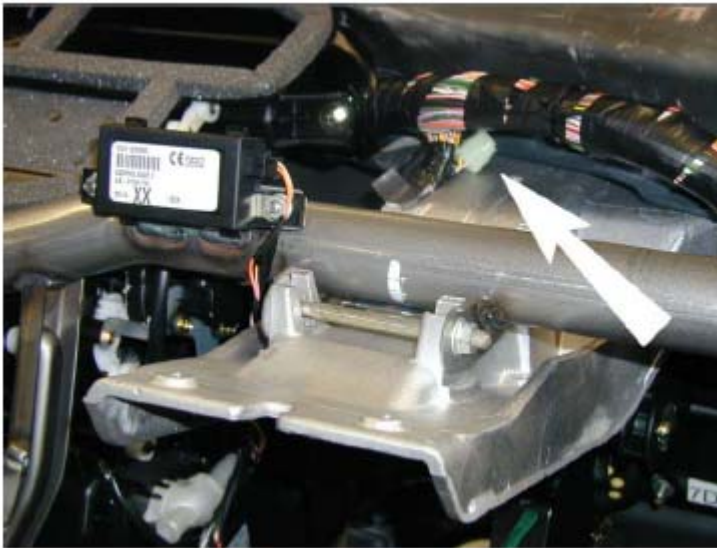
2

4. Referring to illustration 2, look for a taped back break-out wire section on the main harness (arrowed). If this is found, the Traffic Alert wiring has been fitted but not connected. Free the breakout wiring and reroute below the facia cross tube. If breakout wiring is found go to item 13. If wiring break-out cannot be found, continue as follows.

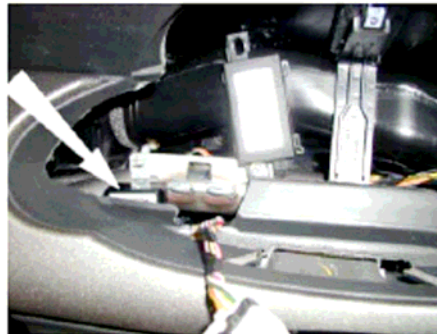
13. If not already fitted, obtain Traffic Alert ECU (part number XVS000030) and connect to the breakout wiring / link lead connector. Fit ECU to the vacated left hand remote receiver stud with the ECU facing down as shown in illustration 5. Refit remote receiver and refit and tighten both fixings. Refit instrument binnacle and confirm that Traffic Alert is now operating correctly.
